INFORMATION CIRCULAR HOB BURNERS – CORRECT ASSEMBLY

Thetford appliances utilise high efficiency type hob burners which will provide many years service. After cleaning burner parts it is important to correctly reassemble otherwise the performance will be degraded. Incorrect reassembly is equivalent to operating in an abuse situation and may lead to damage. The following details correct assembly method.

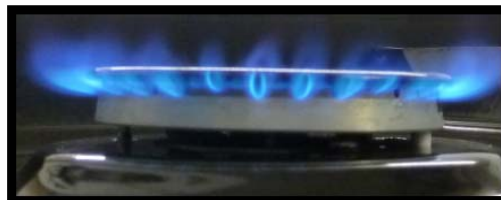
Light the burner and adjust to full rate. The flames should burn quietly and be well defined on each of the burner ports as shown opposite.

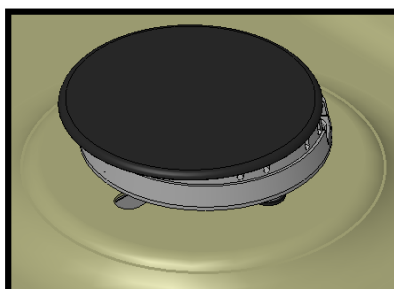
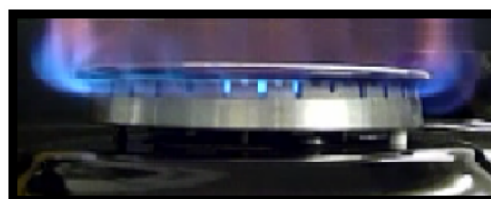
Poor location of burner cap – shown opposite will result in poor defined flames and/or noise from the burner. In either situation turn off and rectify.
